SINGLE IMPLANT – AESTHETIC ZONE
Case Study
Nexus Dental Laboratory

Implant crown for UR1

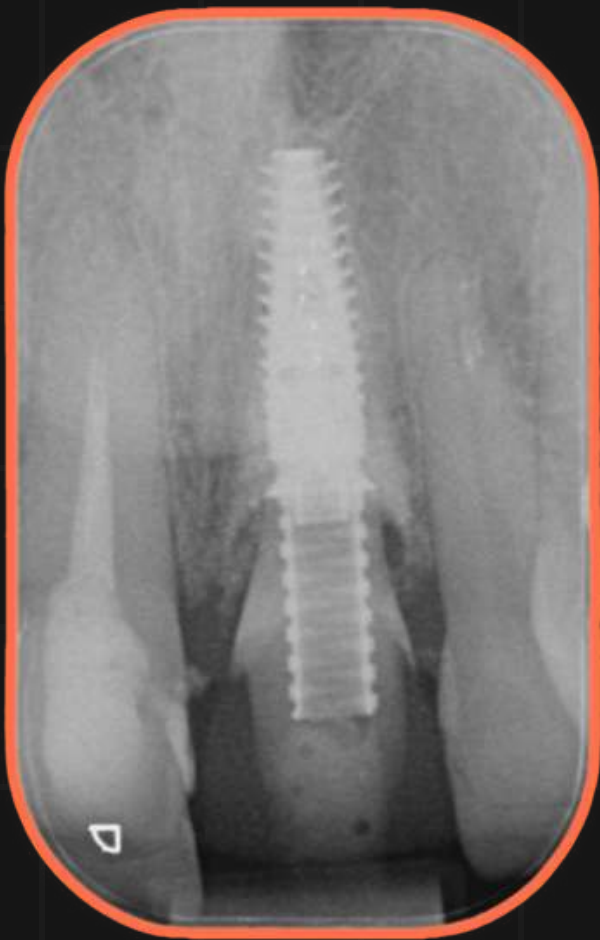
A young male patient presented with an old, deteriorating dental crown that required replacement. Upon examination, it was found that the tooth beneath the crown had developed a significant crack, rendering it non-restorable.

Considering the structural damage and the patient's high expectations for a durable and aesthetically pleasing outcome, the decision was made to remove the tooth and proceed with the placement of a dental implant to restore both function and appearance.

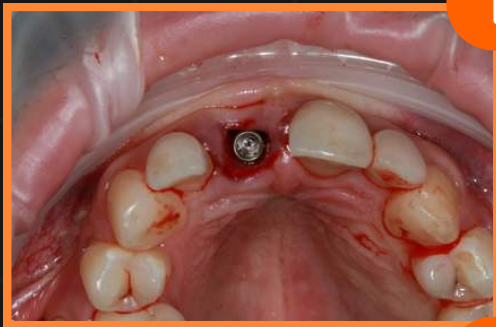
Image number one shows the dental implant immediately after placement, demonstrating optimal positioning and stability.

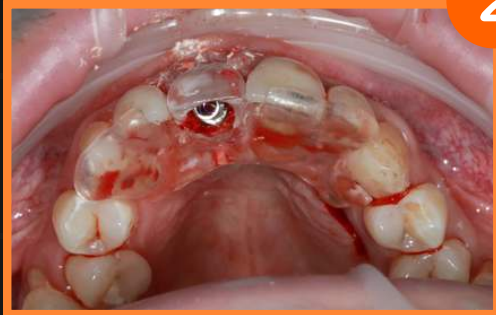
Image number two features the surgical stent used during the procedure, alongside the temporary stock abutment, highlighting the precision tools and provisional components employed to ensure accurate placement and functional aesthetics during the healing phase..

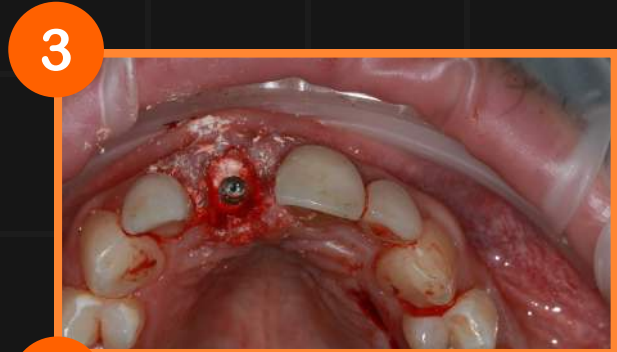
Image number three showcases the synthetic bone grafting material used to enhance the implant site, ensuring adequate bone volume and support for long-term stability.

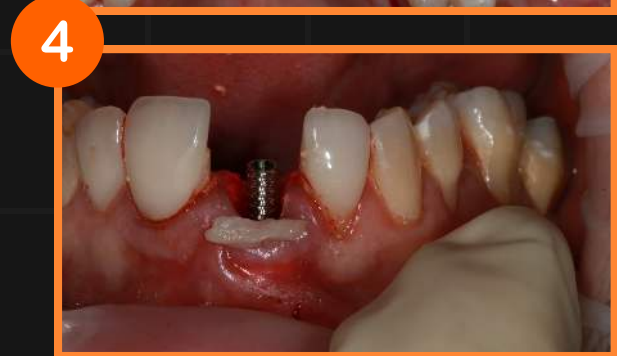
Image number four highlights the gum grafting procedure, demonstrating the soft tissue augmentation performed to improve gingival phenotype and achieve an optimal aesthetic contour around the implant site.

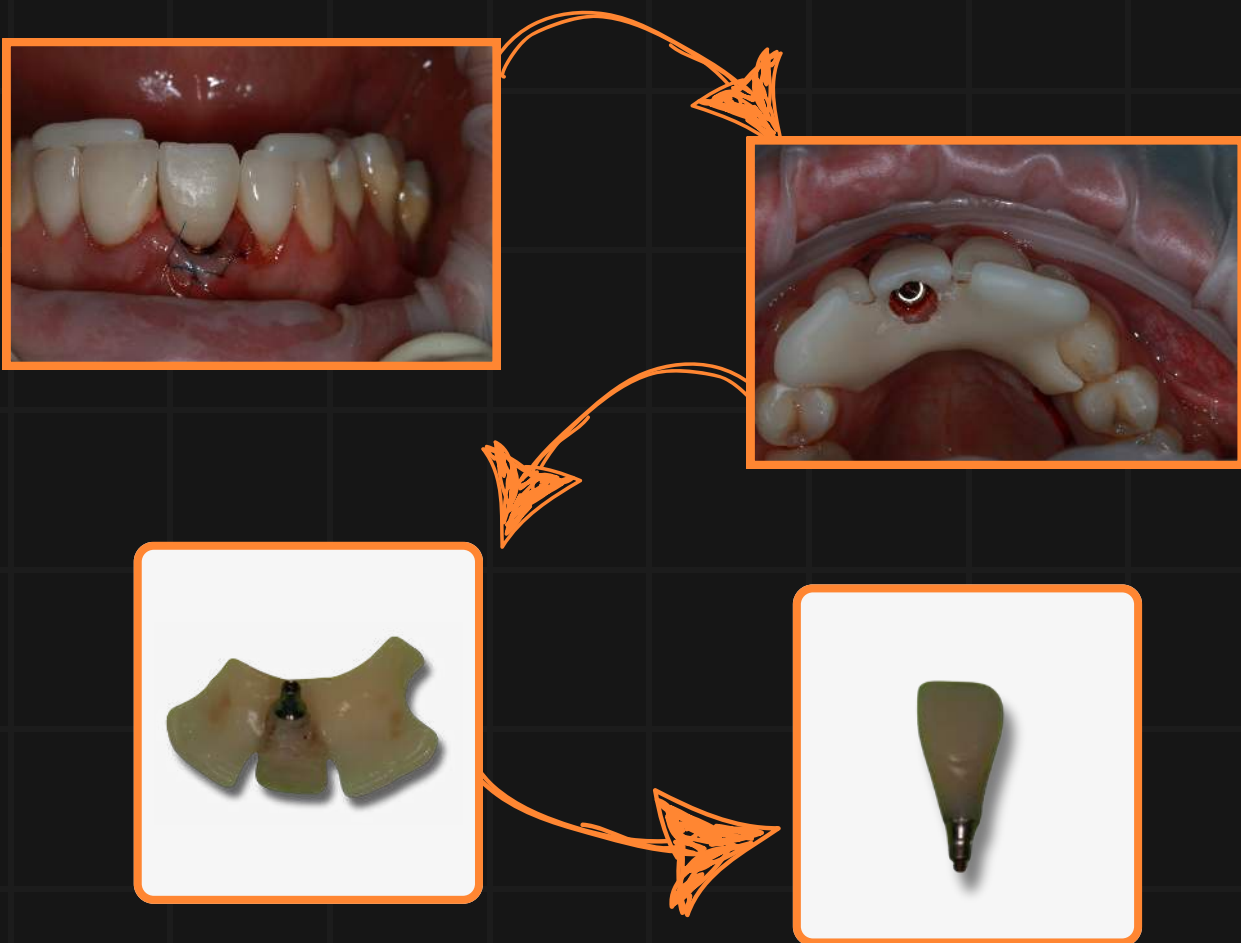
From Removable to Fixed Crown

A removable guide containing a temporary tooth is positioned over the implant site. Using composite resin, the temporary tooth is initially linked to the temporary abutment while in place.

Once removed, additional composite is applied to reinforce the connection and to shape the desired emergence profile for optimal soft tissue support. Finally, the temporary crown is carefully separated from the guide, leaving a functional and well-contoured provisional restoration.

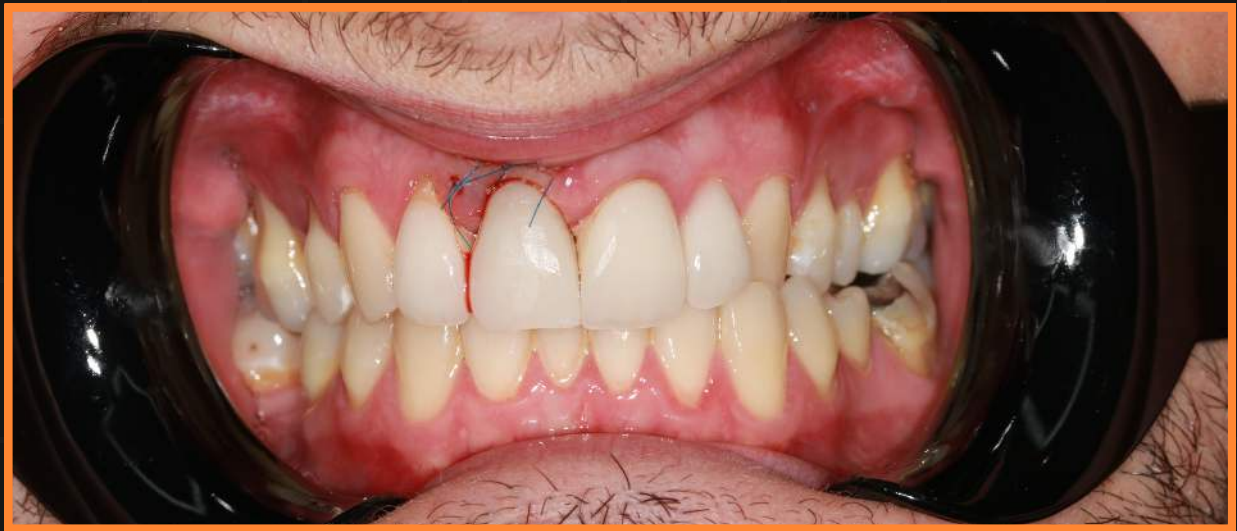
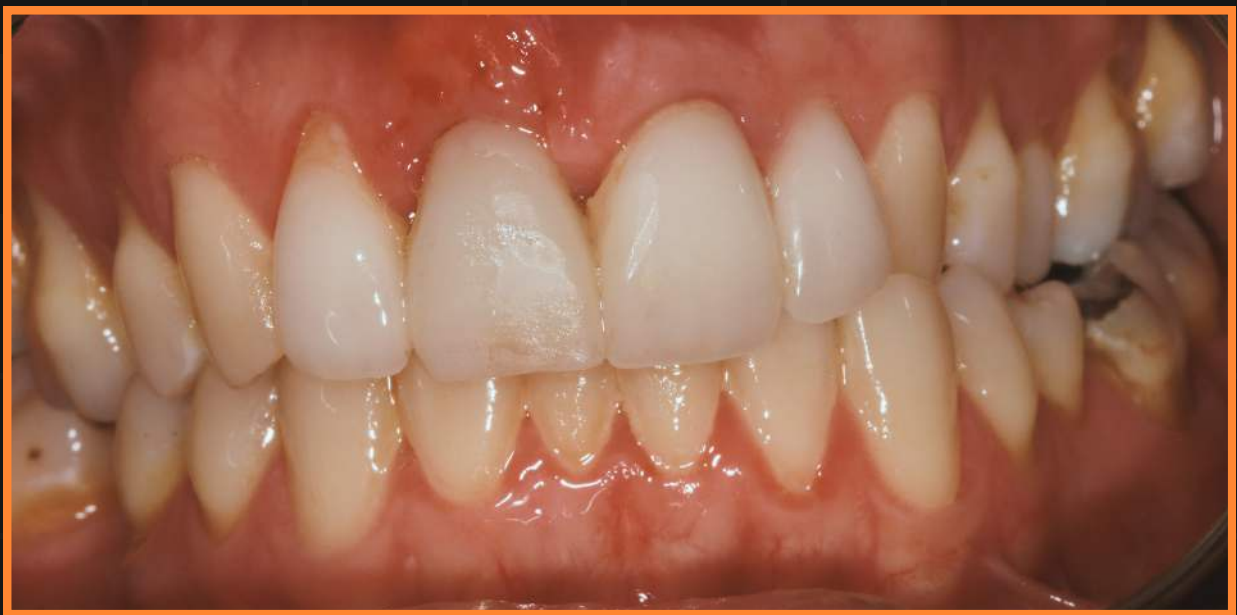
Time to Heal

The patient was sent home with a few small sutures in place to secure the connective tissue graft. This approach aimed to achieve the best possible aesthetic outcome, ensuring a similar emergence profile and ideal cervical area height around the implant site. The accompanying photos illustrate the site with and without the sutures, highlighting the progression of tissue adaptation.

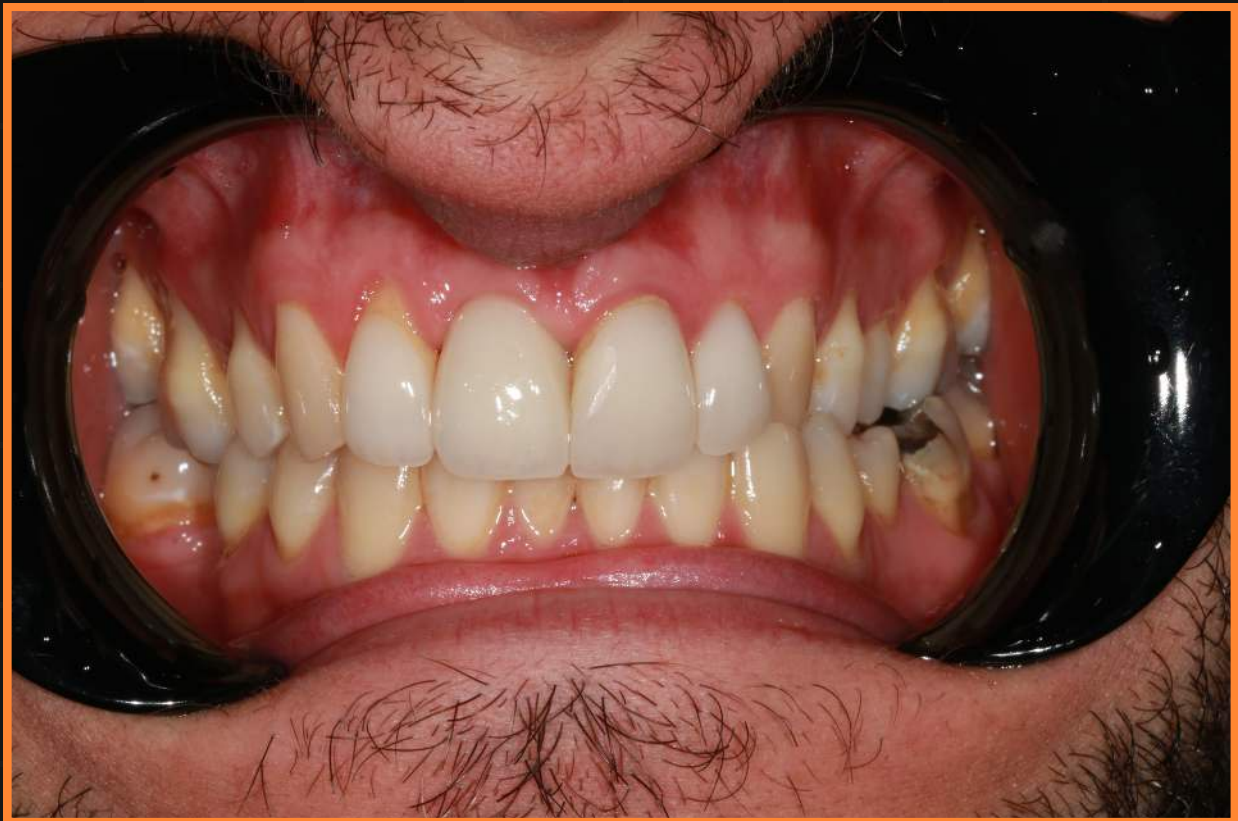
Final Crown Placement

The final restoration was a screw-retained zirconia crown with buccal porcelain layering to enhance aesthetics.

The emergence profile was meticulously copied from the temporary crown to maintain the soft tissue contour achieved during the healing phase.

Additionally, the subgingival area in contact with the soft tissue was crafted with highly polished zirconia, promoting optimal adhesion and tissue health. This approach ensured a durable, functional, and natural-looking result.
