SINGLE IMPLANT – CANTILEVER BRIDGE
Case Study
Nexus Dental Laboratory

Overview

Implant UR4

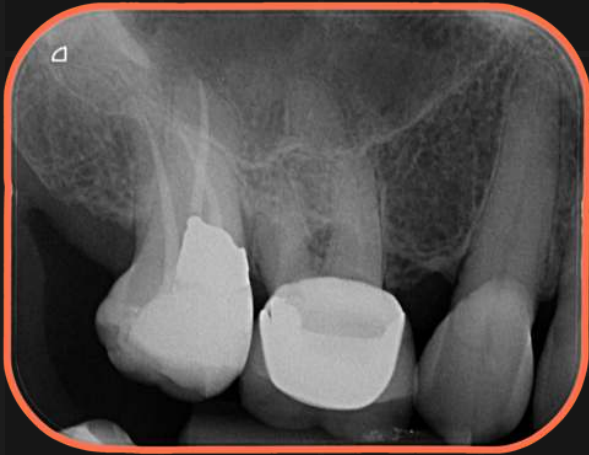
This case details the removal of a compromised 1.4 tooth. The treatment plan involved placing a dental implant at the 1.4 site to support a cantilever bridge extending to 1.5 and later restoring 1.6 with a crown.

The initial X-ray captures the pre-extraction state, underscoring the need for careful planning to restore function and aesthetics.

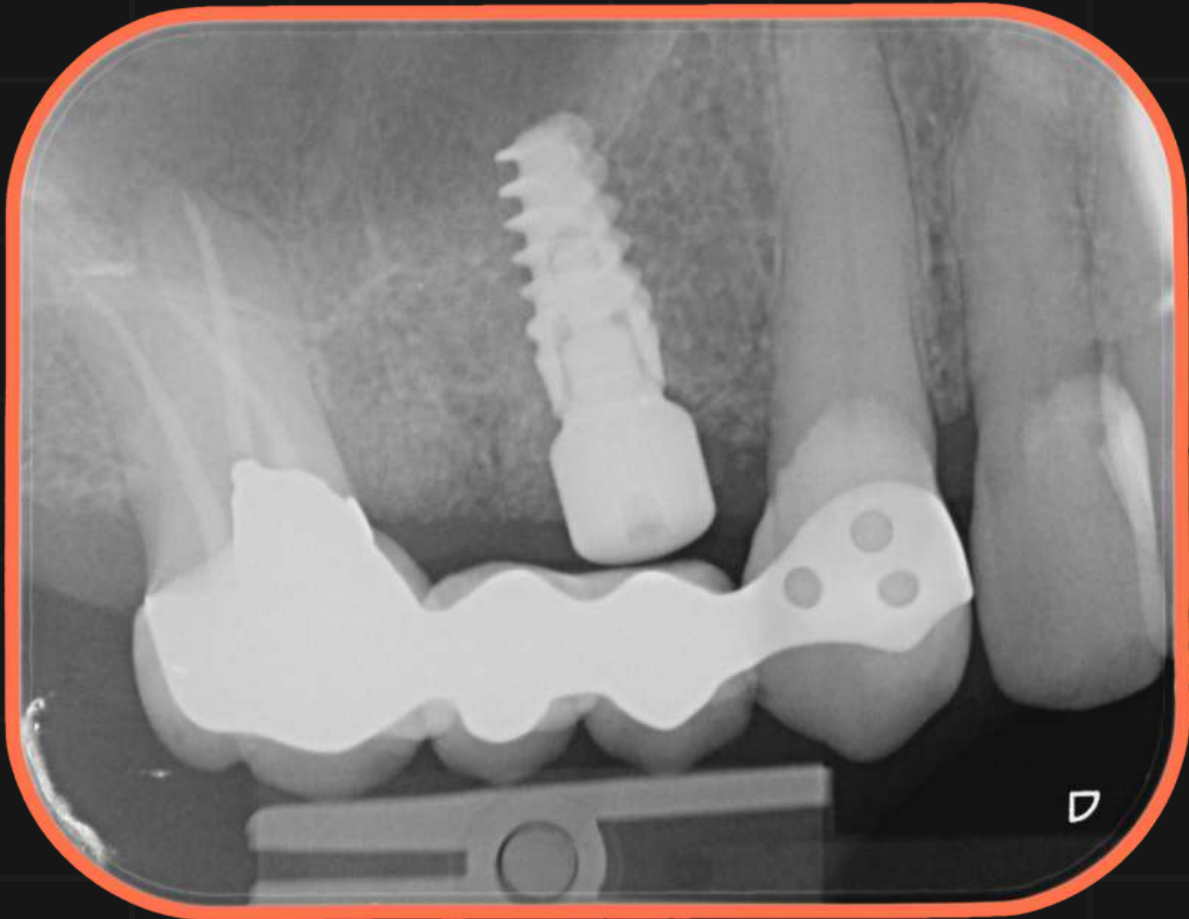
Following the extraction and implant placement at 1.4, a Maryland bridge was utilised, bonded to teeth 1.3 and 1.6, to safeguard the implant during the healing phase.

This provisional restoration plays a pivotal role in protecting the implant from undue mechanical stress, facilitating optimal osseointegration.

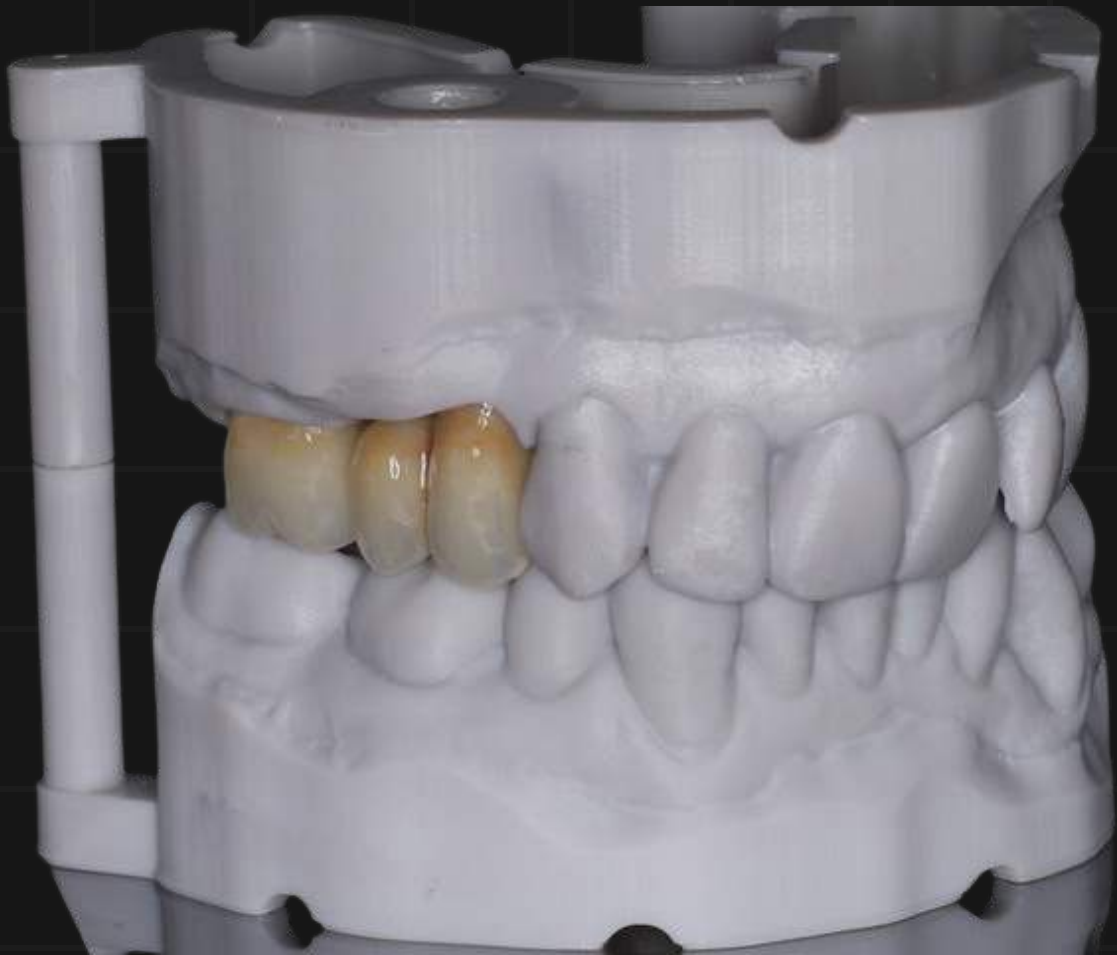
The Maryland bridge was meticulously crafted in the laboratory. Image showcase the bridge on dental models, highlighting the precision of zirconia fabrication to ensure a snug fit.

The lab process is critical in achieving accurate restorations that not only fit well but also contribute to the overall success of the implant by maintaining proper occlusion and aesthetics

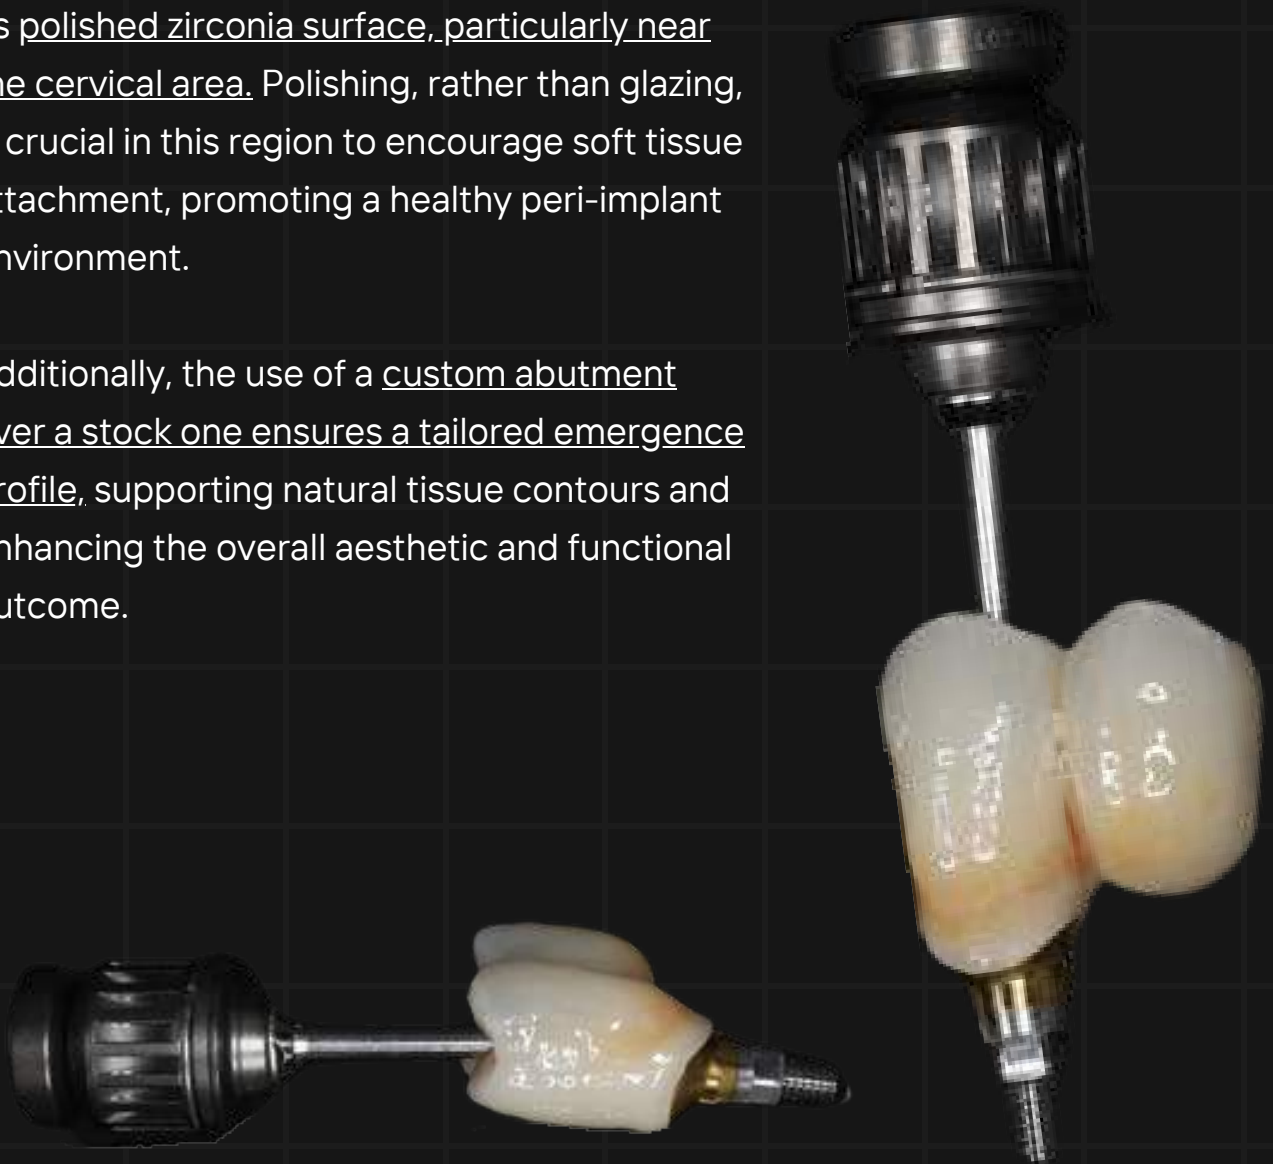
Detailed images of the Maryland bridge reveal its polished zirconia surface, particularly near the cervical area. Polishing, rather than glazing, is crucial in this region to encourage soft tissue attachment, promoting a healthy peri-implant environment.

Additionally, the use of a custom abutment over a stock one ensures a tailored emergence profile, supporting natural tissue contours and enhancing the overall aesthetic and functional outcome.

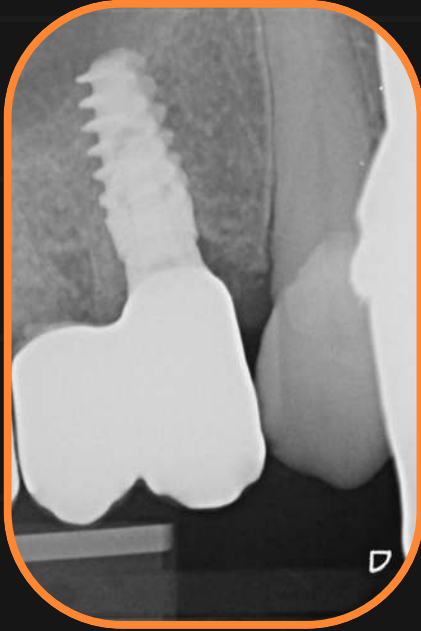
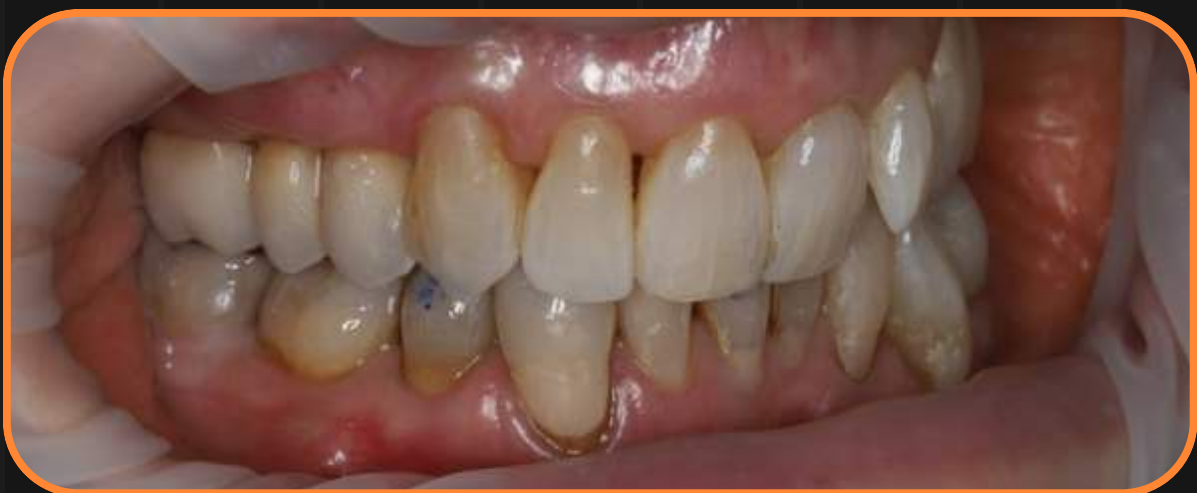
The final stage involved placing a crown on the healed implant at 1.4, with a cantilever extension to 1.5, and a separate crown on 1.6.

Post-treatment photographs display the impressive components fitting and full-mouth results, demonstrating restored dental function and a pleasing aesthetic appearance.

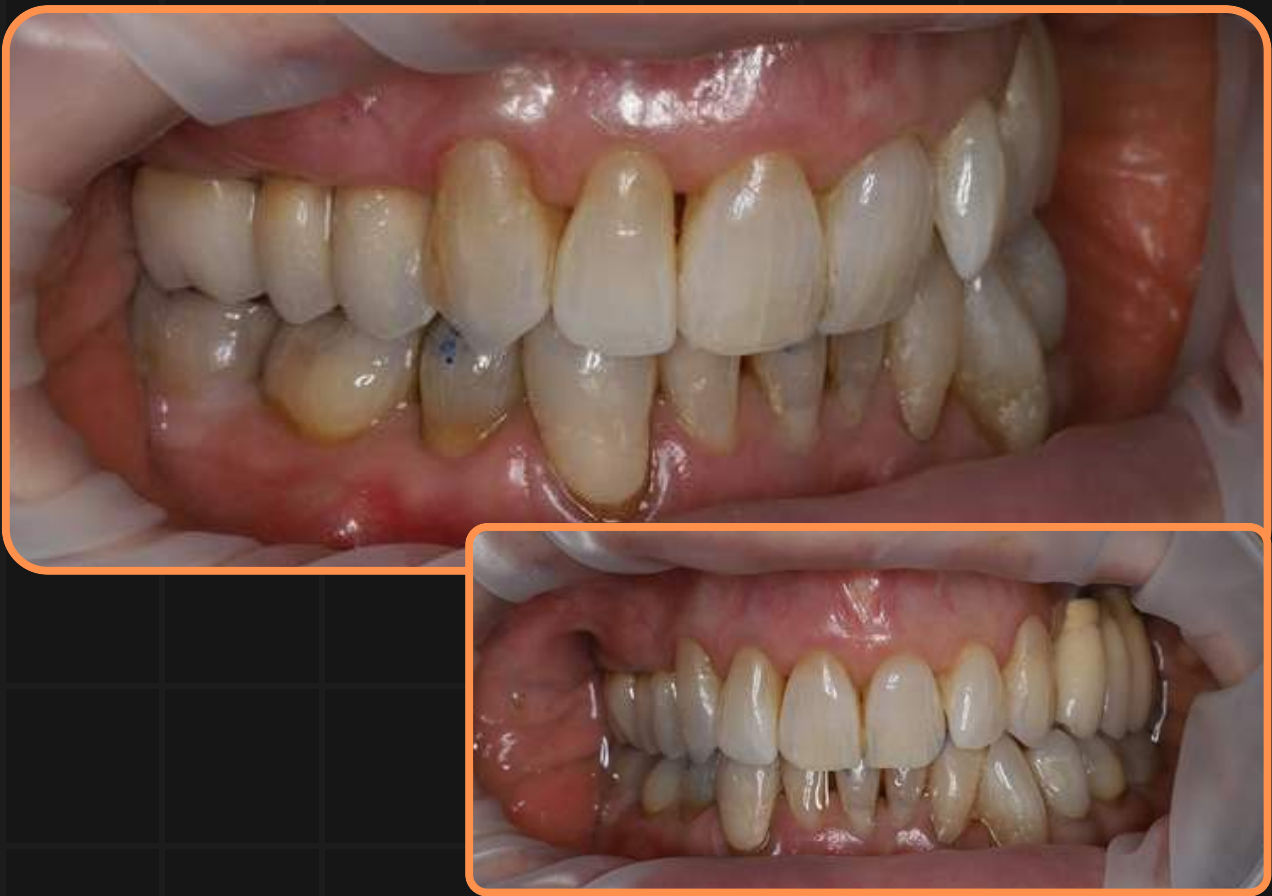
The thoughtful design of the abutment shape and precise zirconia polishing at the neck supported soft tissue integration and long-term stability. The result is a functional and aesthetically pleasing restoration, emphasising meticulous planning and execution in implant dentistry.

Post-treatment photographs display the impressive components fitting and full-mouth results, demonstrating restored dental function and a pleasing aesthetic appearance.
